Inspection Report

456 Random Ave.
Anytown VA 12345

HWS Inspections, LLC

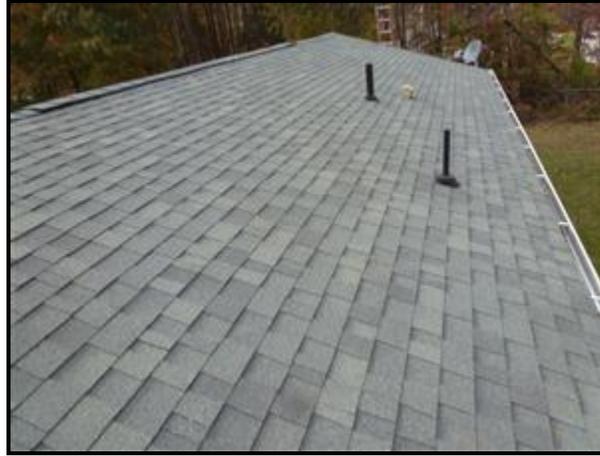
Roof,Back viewed R to L

1.0 The roof appears to be in near new condition. This type of shingle roof in normal conditions may last 15 to 20 years.

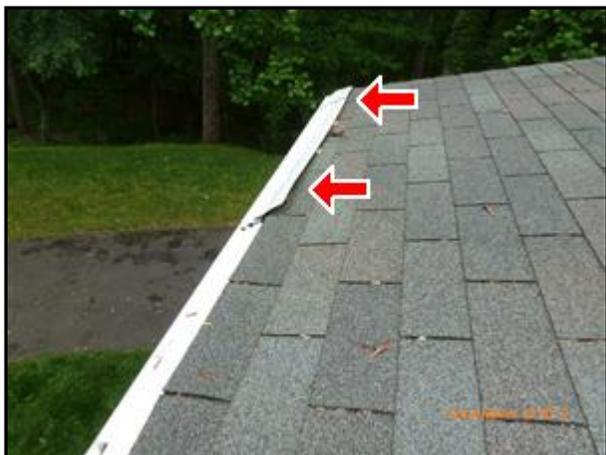
1.3 Picture 1 back right

1.3 The section of gutter guard noted in this photograph(Picture 1) is not properly installed and may allow debris to get into the drainage system. This could cause blockages,over flows and damage to either the gutter or an adjacent portion of the home. I recommend that a qualified contractor clean the gutters and re-install the gutter guard .As a maintenance item ,cleaning and inspecting the gutters should occur twice a year.

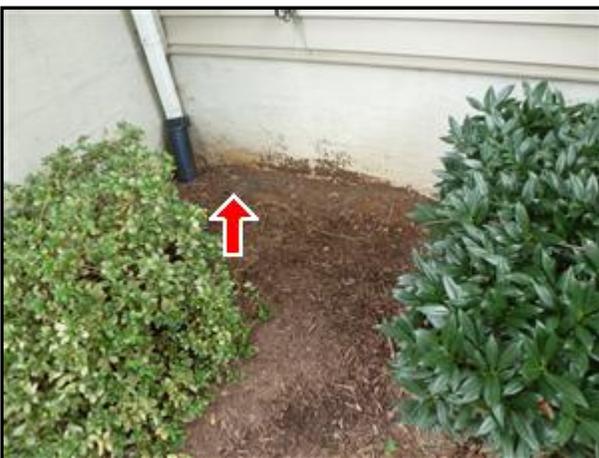
2.4 Picture 2 left front wall, basement

2.4 (Picture 1) This area at the left front of the home has a negative slope .This is causing water to flow to the foundation and moister is present inside the basement opposite this area(Picture 2). I recommend a qualified contractor render the necessary repairs to waterproof the foundation and correct the negative slope

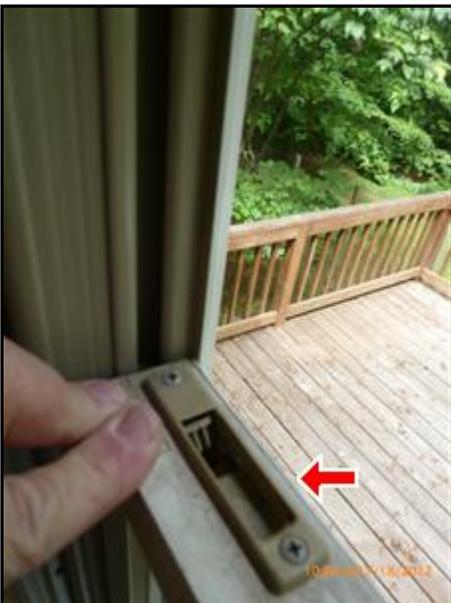
4.6 Picture 1 2nd floor, right rear bedroom

4.6 (Picture 1) The tilt feature bracket of this window sash is broken. I recommend that this item be repaired to assure proper seal and function of this window.

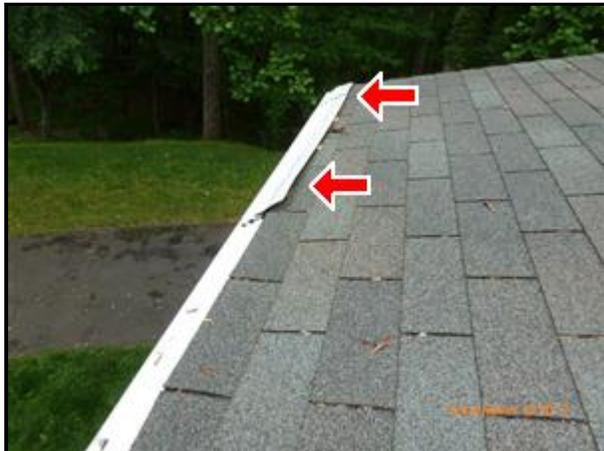
1.3 Picture 1 back right

The section of gutter guard noted in this photograph(Picture 1) is not properly installed and may allow debris to get into the drainage system. This could cause blockages,over flows and damage to either the gutter or an adjacent portion of the home. I recommend that a qualified contractor clean the gutters and re-install the gutter guard .As a maintenance item ,cleaning and inspecting the gutters should occur twice a year.

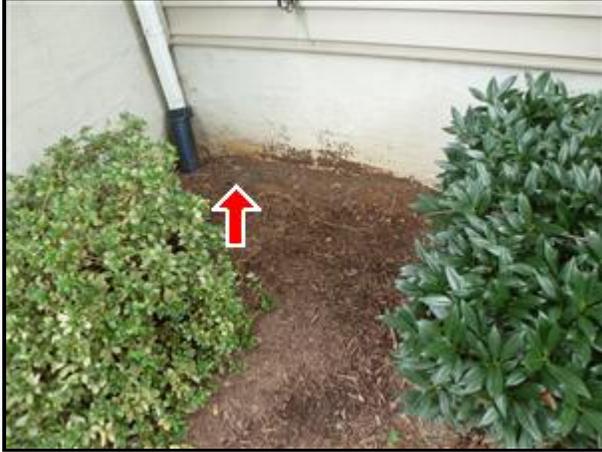
2.4 Picture 1 left front of home

(Picture 1) This area at the left front of the home has a negative slope. This is causing water to flow to the foundation and moisture is present inside the basement opposite this area (Picture 2). I recommend a qualified contractor render the necessary repairs to waterproof the foundation and correct the negative slope
